Re: Portland Harbor Superfund Site, Portland, Oregon; Linnton Plywood Association  
Settlement Offer

**LINNTON PLYWOOD ASSOCIATION – TECHNICAL EVALUATION**

**Upland Site:** Linnton Plywood Association  
 10504 NW Saint Helens Road (Fig. 1)  
 26.5 Acres  
 RM 4.4 to 4.8

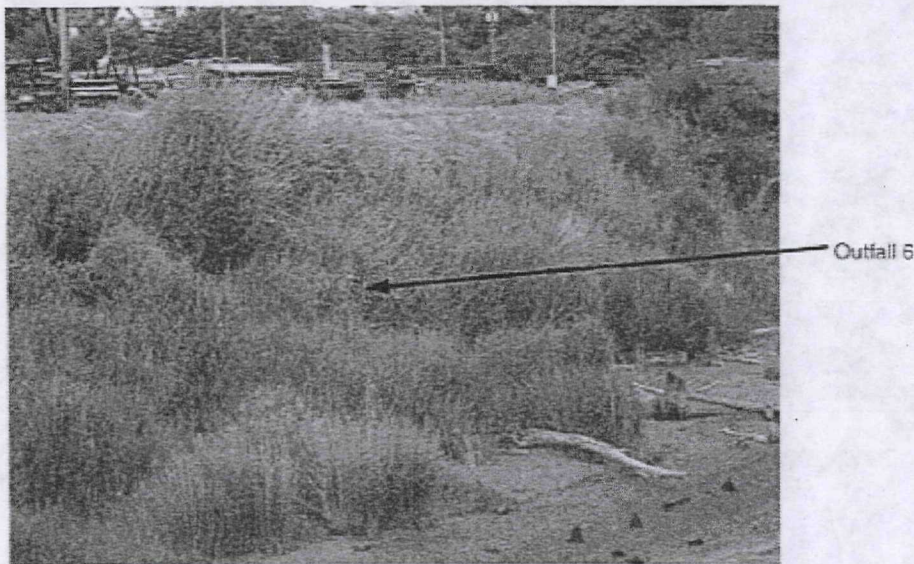
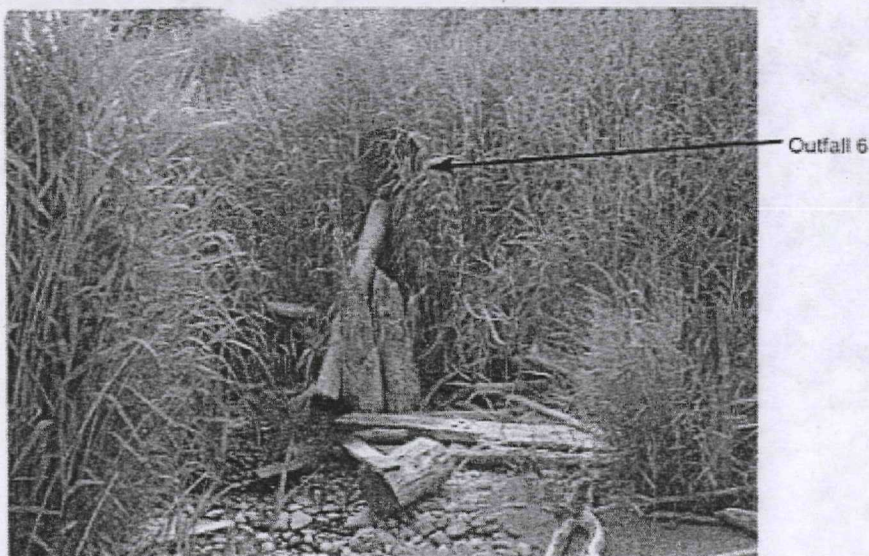
Outfall 6: The drainage basin for this outfall is the paved area on the western side of the plywood mill. Drainage basin includes pale oil application area, veneer storage area, scrubber overflow (sander dust burner), sander dust burner, contained barrel filling area, and transformers T1, T5A, T5B, and T5C; may also include railroad lines, sawdust bin, and wood waste fuel bin area. Sampling results may suggest migration of hazardous substances from the pale oil application and overflow from the scrubber used to treat the air discharge from the sander dust burner. The PAH levels detected in sediments at the discharge location of Outfall 6 may suggest a historic potential onsite source. However, as explained above, the pipeline above Outfall 6 receives storm water from upgradient and offsite sources. Accordingly, the recent closing of the facility and the cessation of pale oil application and scrubber usage eliminates these on-site sources as a potential present source and migration pathway. The outfall discharges approximately 10 feet below the paved area grade at an elevation around 16 feet MSL, close to the facility boundary. The discharge then falls an additional 10 feet to the mud flat at the bottom of the slope. Sampling shows that the following chemicals exceed screening levels for this outfall: TPH-oil, lead, zinc, and PAHs (anthracene, benzo-a-anthracene, fluoranthene, phenanthrene, and pyrene). Phenol and pentachlorophenol detection limits were too high (40-60 times SLVs) to determine whether these parameters were of concern.

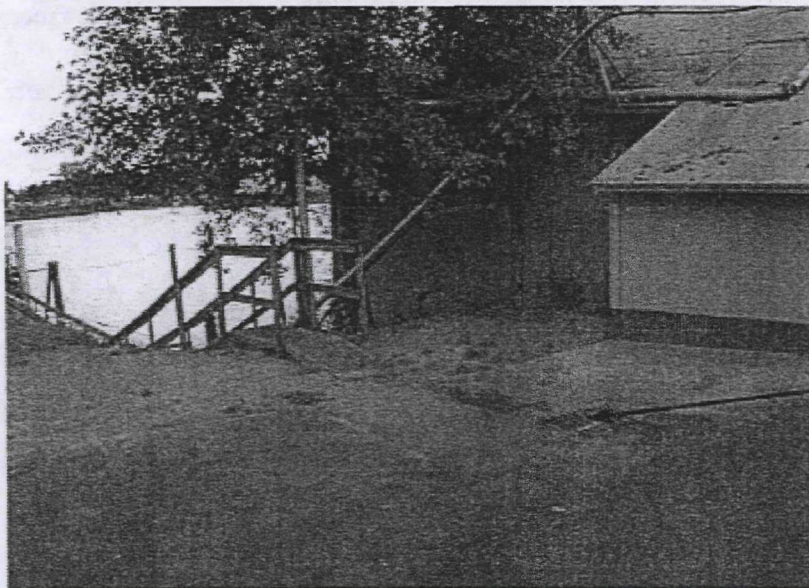
Outfall 5: The drainage basin for this outfall is the paved area on the northwest side of the plywood mill. Drainage basin includes auto repair shop, maintenance shop, pipe shop, diesel tank, steam cleaning area and transformer T2. The floor drain in the maintenance shop and the outdoor steam cleaning pad lead to Outfall 5. The floor drains were installed in the 1950s when the plant was converted to a plywood mill. Outfall 5 is a small-diameter pipe which discharges onto soil near the top of the bank. The outfall discharges approximately 6 feet below the paved area grade onto a vegetated slope above the 17 feet MSL facility boundary. Sampling shows that the following chemicals exceed screening levels for this outfall: cadmium, copper, lead, zinc, and bis(2-ethylhexyl)phthalate. Phenol and pentachlorophenol detection limits were too high (40-60 times SLVs) to determine whether these parameters were of concern.

Oil Separation  
Catch Basin  
for Outfall 5

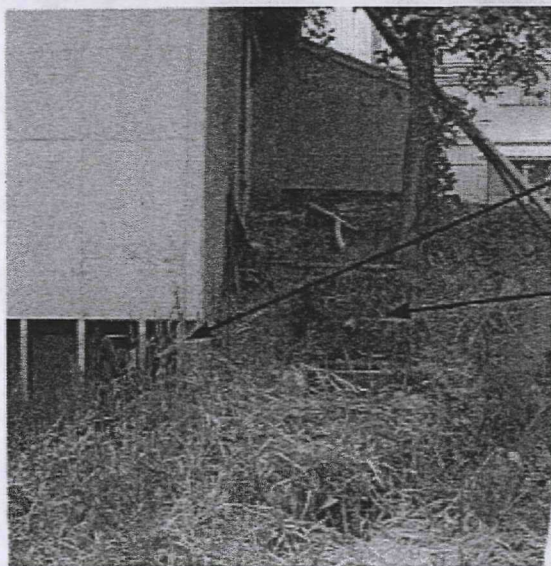
Outfall 5

Abandoned  
Pipe

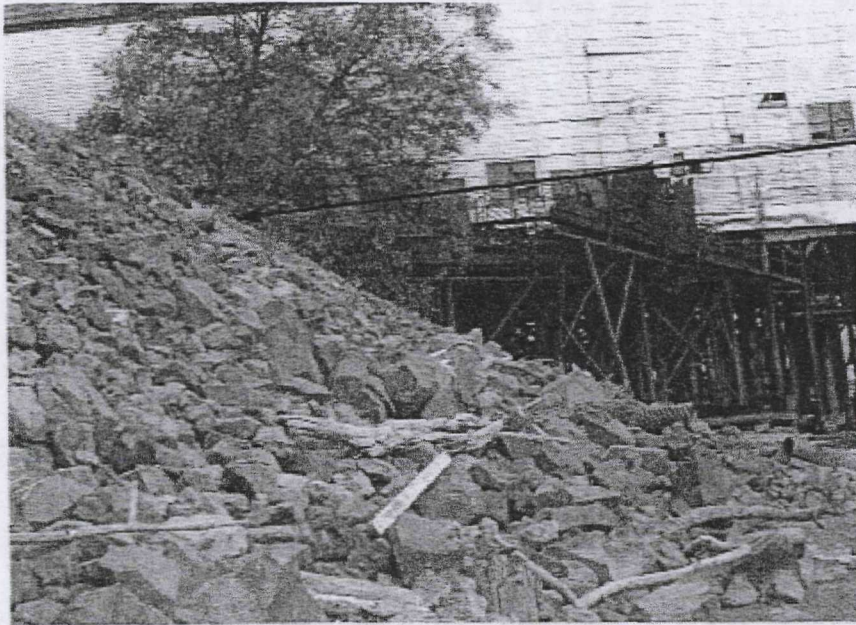
Outfall 4: Outfall 4 is located 30 feet downstream of outfall 3. This outfall drains storm water from the roofs of the plywood mill. The outfall discharges approximately 10 feet below the paved area grade onto a riprap slope above the 17 feet MSL facility boundary. This outfall was not sampled.

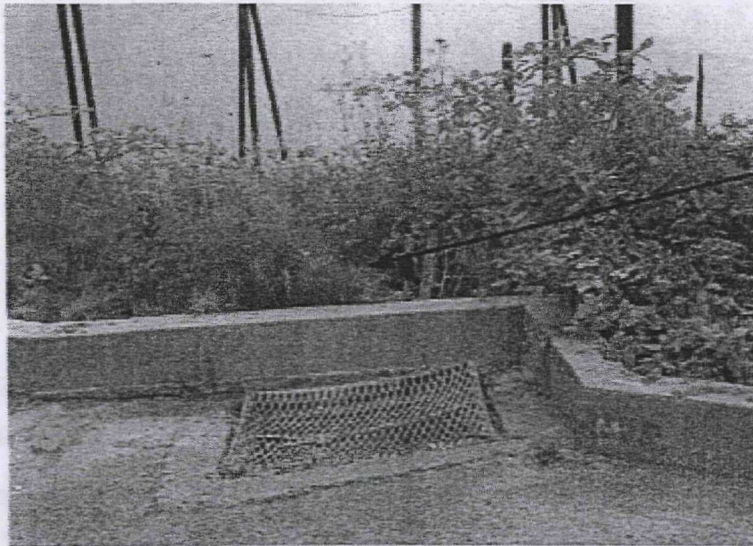
Outfalls 3 and 3A: The drainage basin for this outfall is the paved area on the southeast side of the plywood mill, west of the drainage basin for outfall 2. The outfall discharges approximately 2 feet below the paved area grade onto a riprap slope above the 17 feet MSL facility boundary. Drainage basin includes hog fuel bin, boiler house, diesel AST, caustic AST, resin AST, propane AST, oil AST, gasoline UST, and transformers T4A, T4B, and T4C. Sampling shows that none of the chemicals analyzed exceed screening levels for this outfall. Benzo(a)pyrene, phenol and pentachlorophenol detection limits were too high (40-60 times SLVs) to determine whether these parameters were of concern.

Catch basin  
discharge on other  
side of curb.

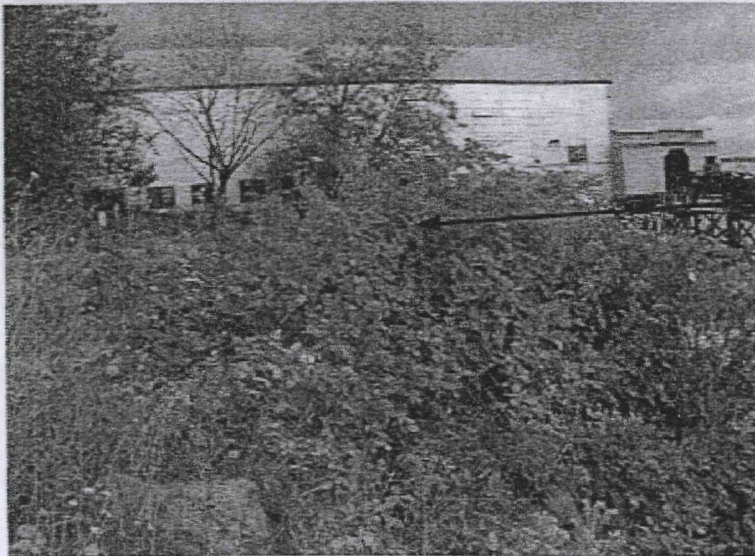
Bank below  
Outfall 3.

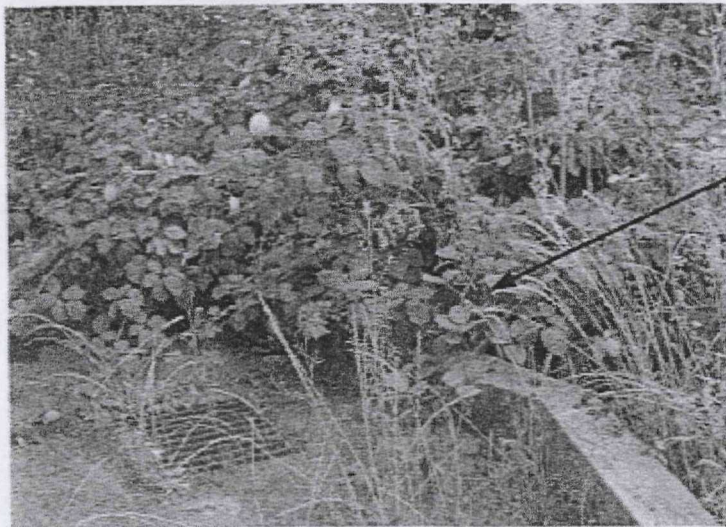
Outfall 2: The drainage basin for this outfall is the paved area on the southeast side of the plywood mill. The outfall discharges approximately 2 feet below the paved area grade onto a riprap slope above the 17 feet MSL facility boundary. Land area where sander dust ash has been placed may also drain to this outfall. Sampling shows that the following chemicals exceed screening levels for this outfall: Phenol and pentachlorophenol detection limits were too high (40-60 times SLVs) to determine whether these parameters were of concern. Sampling shows that none of the chemicals analyzed exceed screening levels for this outfall. Benzo(a)pyrene, phenol and pentachlorophenol detection limits were too high (40-60 times SLVs) to determine whether these parameters were of concern.

Catch basin  
discharge on outhur  
side of curb.

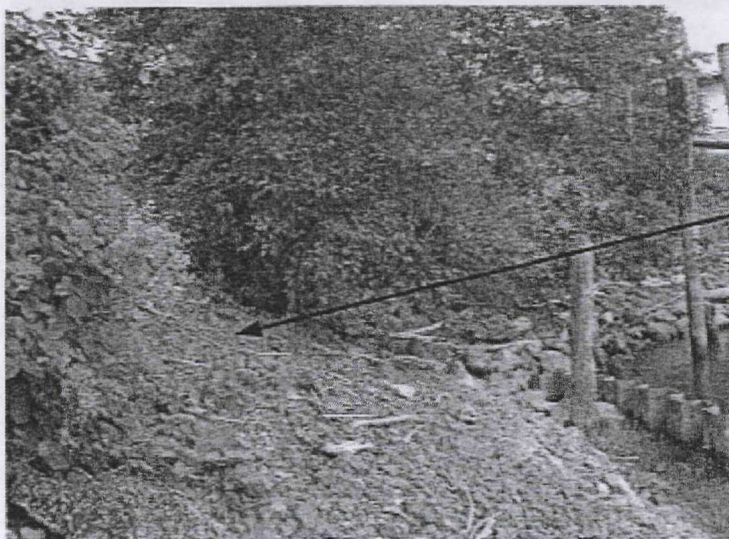
Bank below  
Outfall 2.

- PAHs and dibenzofuran via bank erosion in the area of outfall 2
- PAHs and dibenzofuran via stormwater discharge through outfall 2
- PAHs and metals via stormwater discharge through outfall 5
- VOCs, selected metals, PAHs and dibenzofuran via stormwater discharge through outfall 6
